**Optical Brightener Survey of Three Streams  
in The Lower Neponset River Watershed:  
Pine Tree Brook, Mother Brook and Unquity Brook  
2009-2010**

By: William Guenther  
Environmental Scientist  
Neponset River Watershed Association  
2173 Washington St.  
Canton MA, 02031

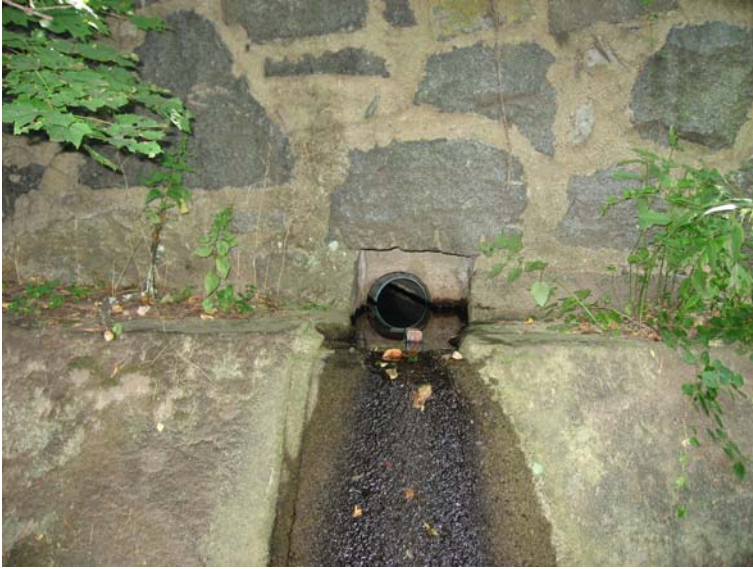
Figure 5: Outfall 38 along Pine Tree Brook. Picture taken in August of 2009.

Outfall 38 was found to have flow twice during sampler retrieval but was negative for optical brighteners (Table 1). Outfall 38 did however exhibit signs of an SSO after heavy rains in March of 2010 after all optical brightener sampling was completed for this outfall (Figures 5 and 6). A picture of the outfall in 2009 shows that while the outfall is releasing flow it is clear in color and there is no discoloration along the wall leading down to the stream prior to the possible SSO (Figure 5). In 2010, after significant rainfall in March a picture of the same outfall shows signs of having had a SSO at some time while the precipitation event was occurring or afterwards. The discharge appears to have become milky in color and there was significant staining along the wall leading to the stream where heavy algae growth and some floatables could be seen (Figure 6).

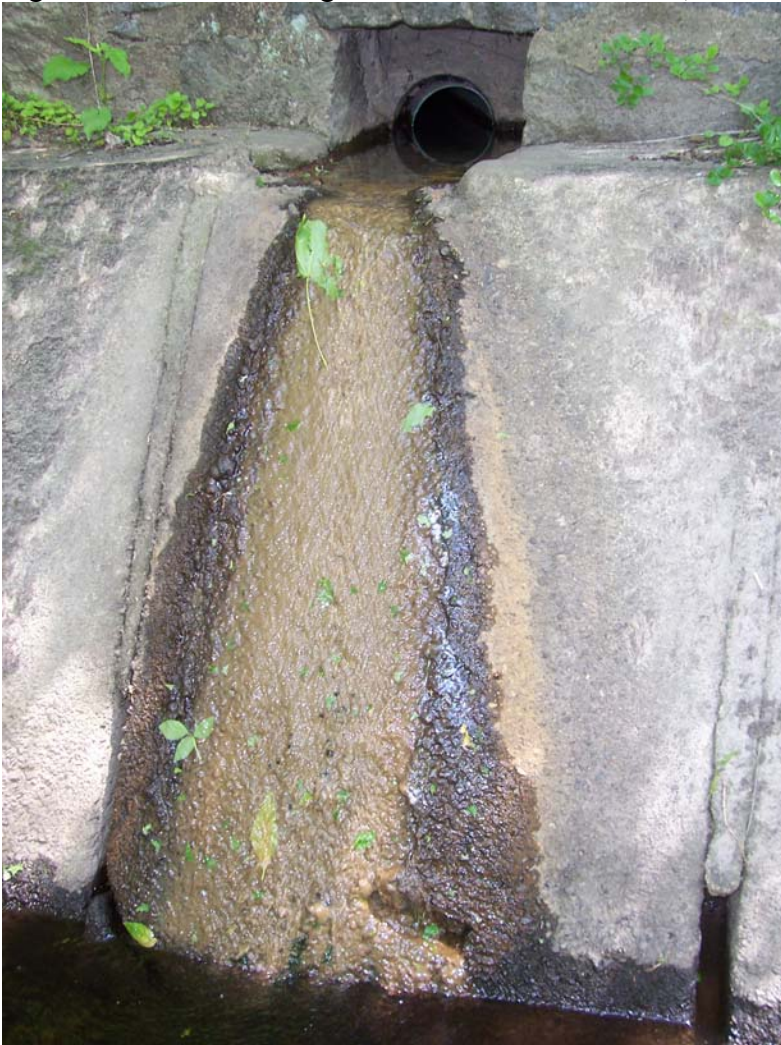
Figure 6: Outfall 38 along Pine Tree Brook in Milton, MA. Picture taken in April of 2010.

In addition to these two outfalls, Outfall 38 will also be brought to the attention of the Town as an outfall that may require further investigation for a SSO. Despite negative results from the optical brightener sampling it is believed that an SSO has occurred at this outfall after the sampling was completed. During sampling in 2009 a picture was taken of the outfall for reference (Figure 5). After heavy rains in March of 2010 the stretch of stream containing OF 38 was revisited as part of an assessment of the brook after the precipitation event. A new picture was taken of the outfall due to discoloration of the wall leading to the brook and the evidence of floatables in the effluent (Figure 6). It is not known if the SSO is continuing or what specifically caused the SSO other than high volumes of rain water infiltrating into the sewer system. It is our hope that further investigation of this drainage system will find a cause and be able to eliminate this drainage area and outfall from further SSO events.

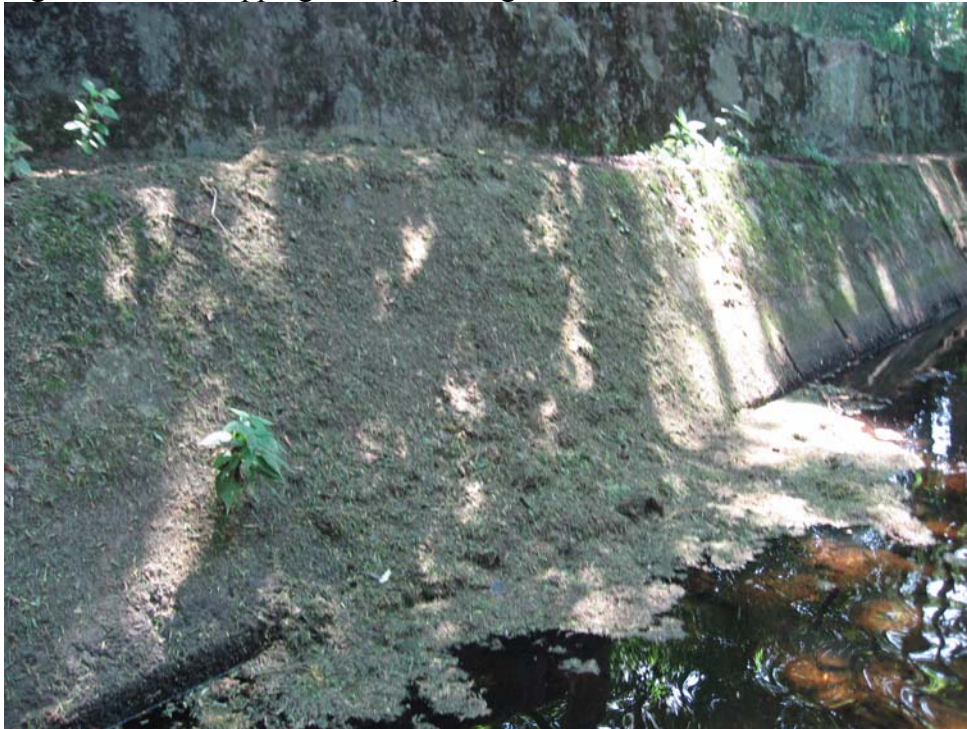
Figure 7: Grass clippings dumped along the bank of Pine Tree Brook in Milton, MA, 2009.

Secondarily to problems at the aforementioned outfalls, it will also be brought to the attention of the Town that at a number of locations along Pine Tree Brook there is dumping of yard waste occurring (Figures 7, 8 and 9). Pictures taken in 2009 and 2010 indicate that along small portions of Pine Tree Brook some homeowners are using the area along the brook to dump yard waste in the form of brush and grass clippings with some regularity. It is our hope that these practices can be eliminated in the near future.

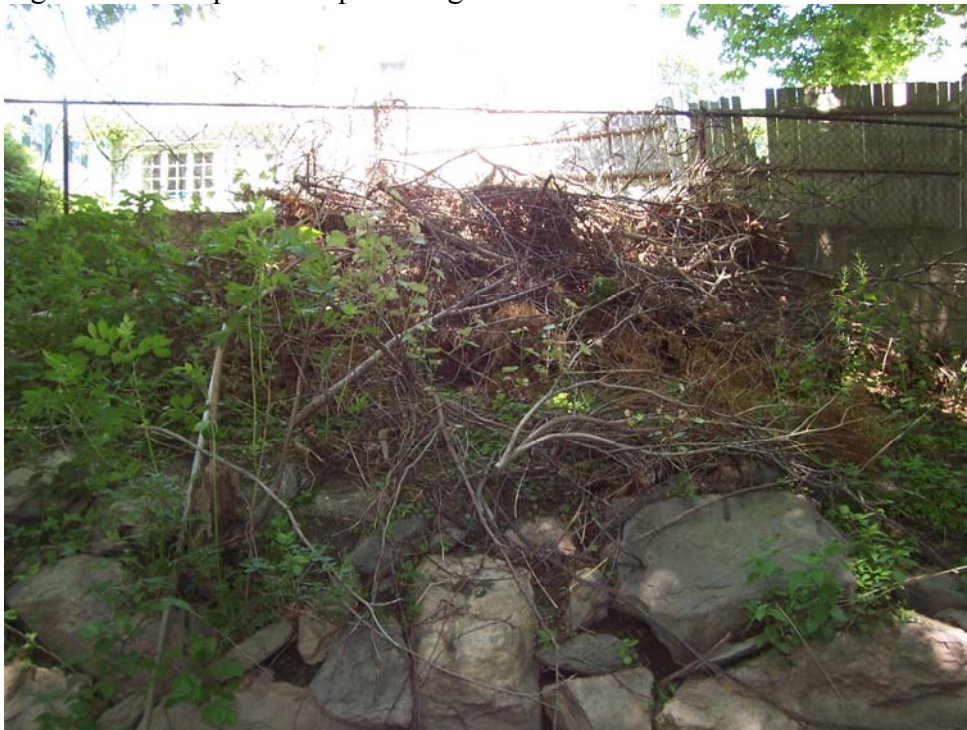
Figure 8: Brush piles dumped along the banks of Pine Tree Brook in Milton, MA, 2010.

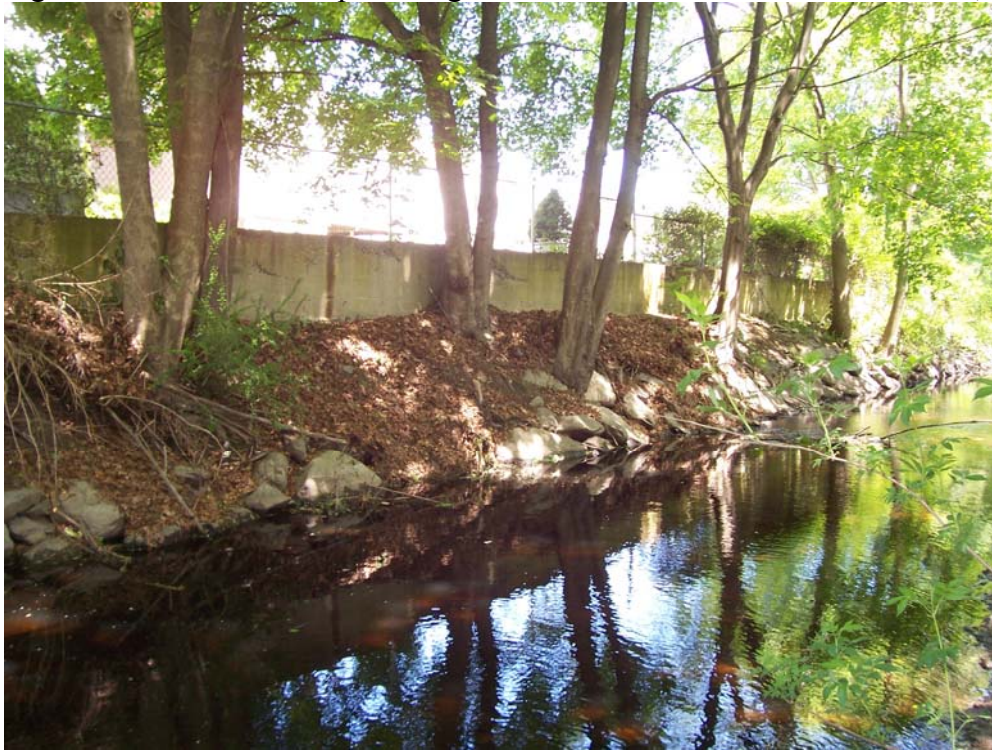
Figure 9: Yard waste dumped along the banks of Pine Tree Brook in Milton, MA, 2010.

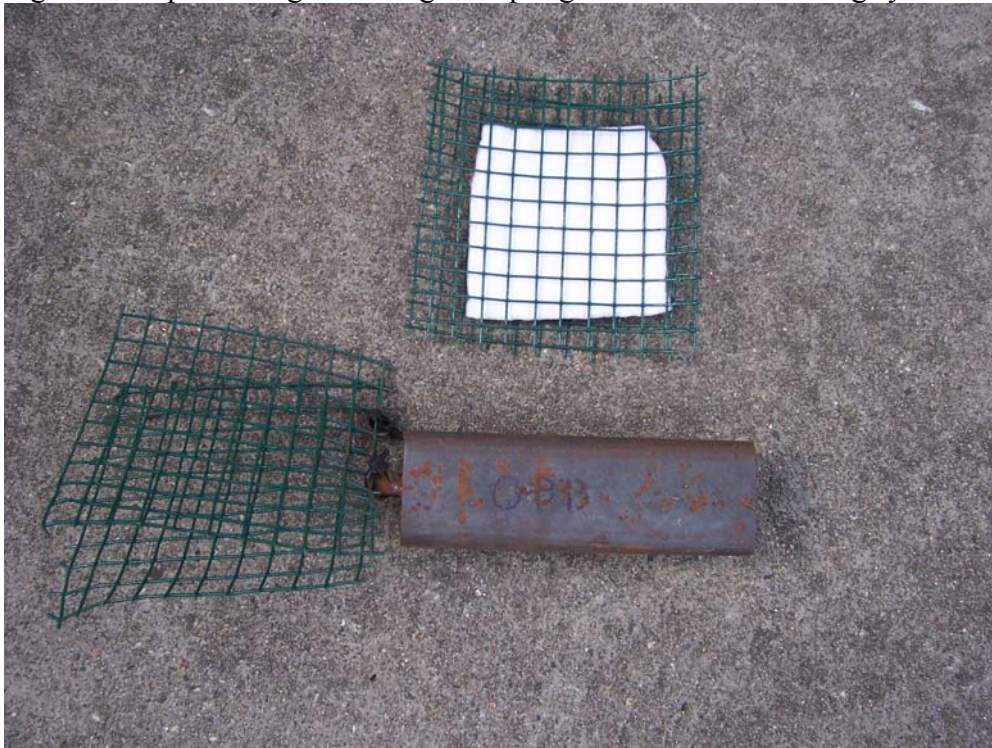
The device used almost exclusively during this study was a cage delivery system (Figure 10). For cage delivery, the sampling pad was placed between two flat wire mesh sheets in order to expose the maximum surface area of the cotton pad to the water. Each end of the cage was then closed with an elastic band or zip-tie to keep the pad firmly in place.

Once the pad was in place the cage was positioned in the area to be sampled, generally a foot or two inside the end of the outfall pipe, and anchored in some manner. Anchoring was primarily achieved by using a zip-tie to connect the wire cage to a steel block with sufficient weight to stay in the outfall. In certain circumstances other cage delivery systems were devised on a case by case basis depending on conditions at individual outfalls.

Figure 10: Optical Brightener cage sampling device with anchoring system attached.
