**DRAFT *Technical Memorandum***  
**Northeast Region Bacteria Source Tracking**  
**2007 Results**

January 2008

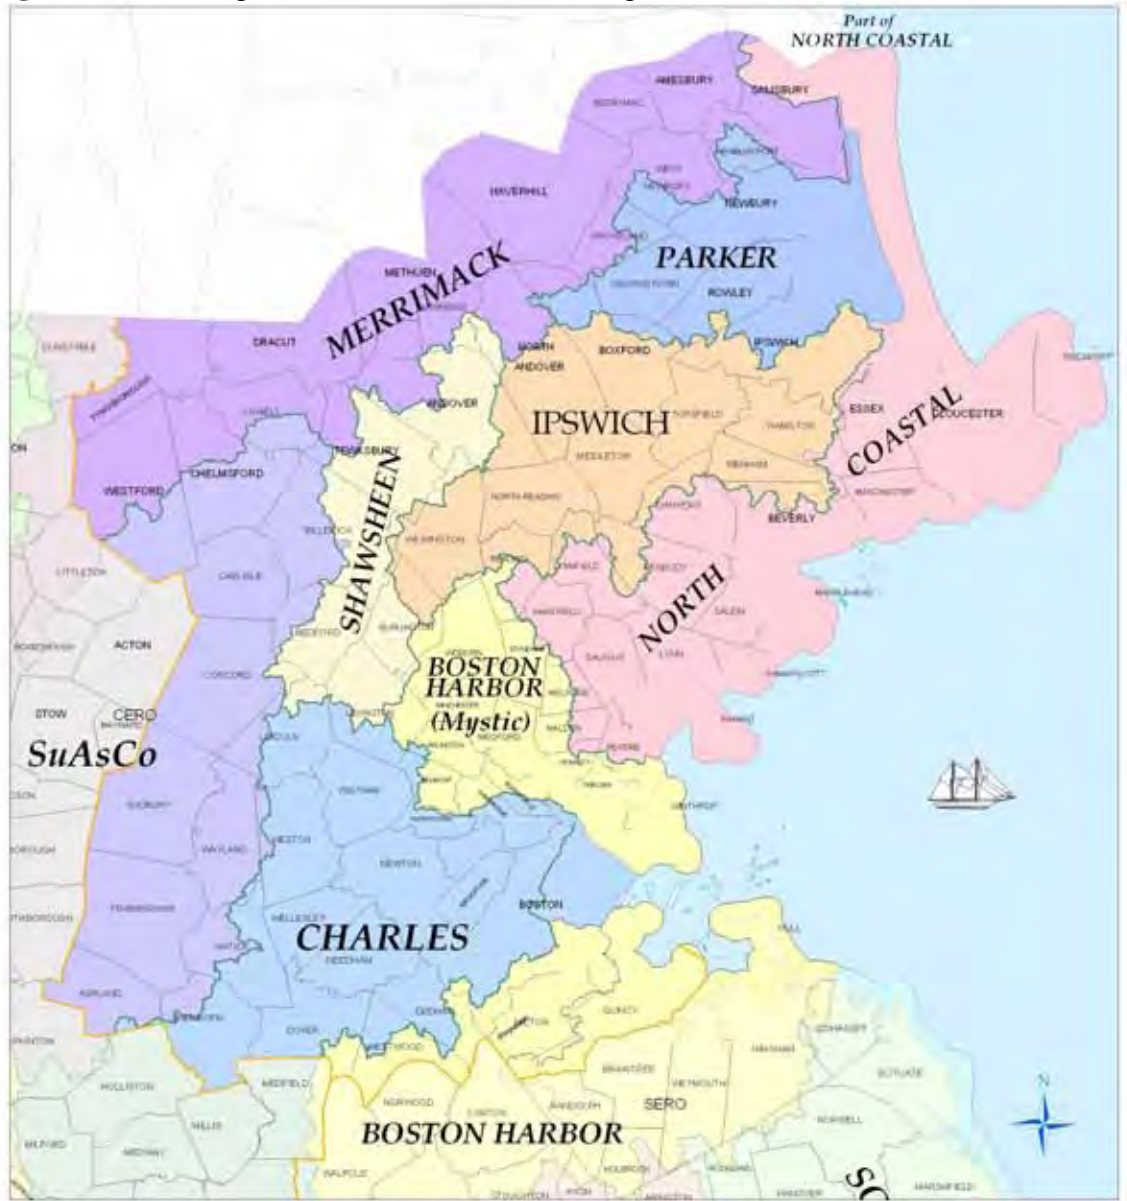
**Figure 1.** 2007 Targeted Bacteria Source Tracking Basins

One "targeted" sub-watershed from each basin in the northeast region was initially selected to undergo screening level sampling. These basins were: Boston Harbor (Neponset and Mystic), Charles, Shawsheen, SuAsCo, North Coastal, Merrimack, Ipswich, and Parker (see Figure 1). The Merrimack Basin was not sampled, but additional sub-basins in some of the other basins were sampled. This report summarizes results of sampling conducted May through November 2007.

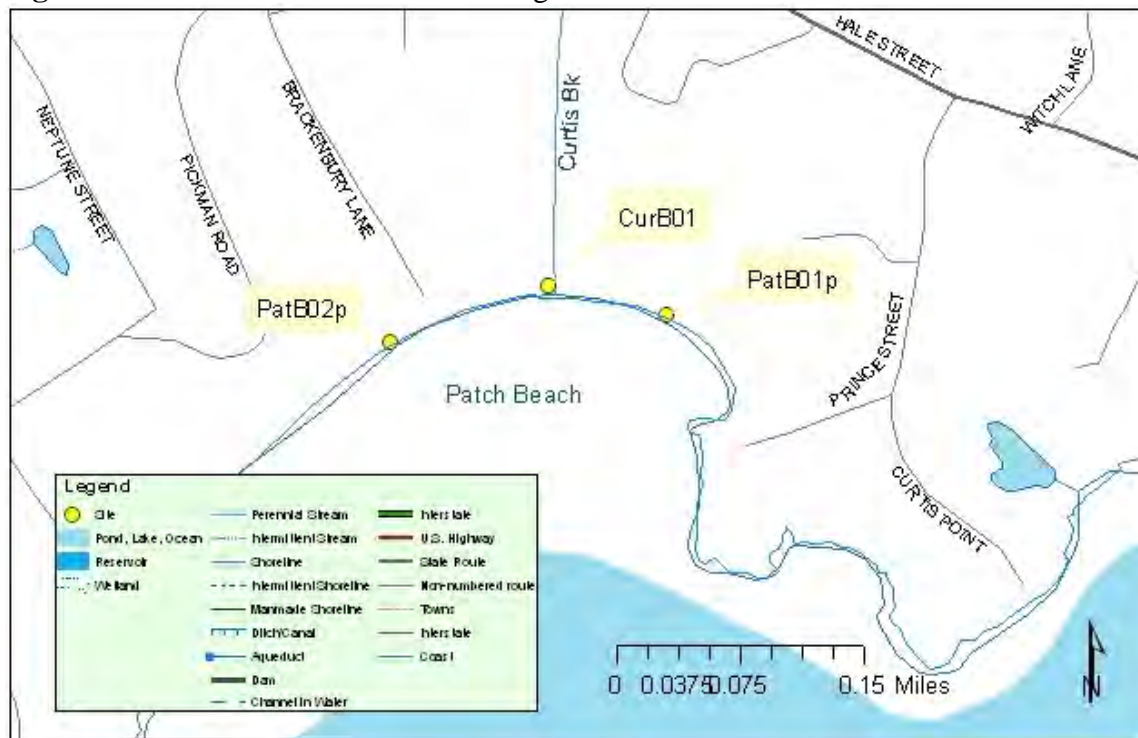
**Figure 12.** 2007 Bacteria Source Tracking Sites at Patch Beach

- Curtis Brook is culverted over much of its length and flows onto Patch Beach. PatB02p is also partially fed by a wetland/stream area.
- The Curtis Brook sub-watershed (CurB01) is 1.6 square miles in area.
- Landuse in the Curtis Brook sub-watershed is characterized as follows: Forest 59%, Residential 28%, Other 5%, Commercial 3%, Open Space 3%, Wetland 2%
- The Curtis Brook sub-watershed is mixed residential and undeveloped land.
- Curtis Brook is not listed as a segment in the 2006 Integrated List of Waters.
- The City of Beverly is a NPDES Phase II community, with 92% sewered and 8% on septic systems.

- CurB01 is a culverted brook that emerges at Patch Beach (also known as Brackenbury Beach). Bacteria levels were slightly elevated on both sampling dates. However, there is a pond north of Hale Street where a large number of ducks and other birds have been observed.

- PatB01p is a pipe whose visible portion is broken and misaligned. Bacteria concentrations in samples collected there ranged from slightly elevated to significantly elevated. Potential for human contact, particularly children, is high. Human marker sampling was attempted at this pipe, but tidal conditions on the sampling date prevented access.

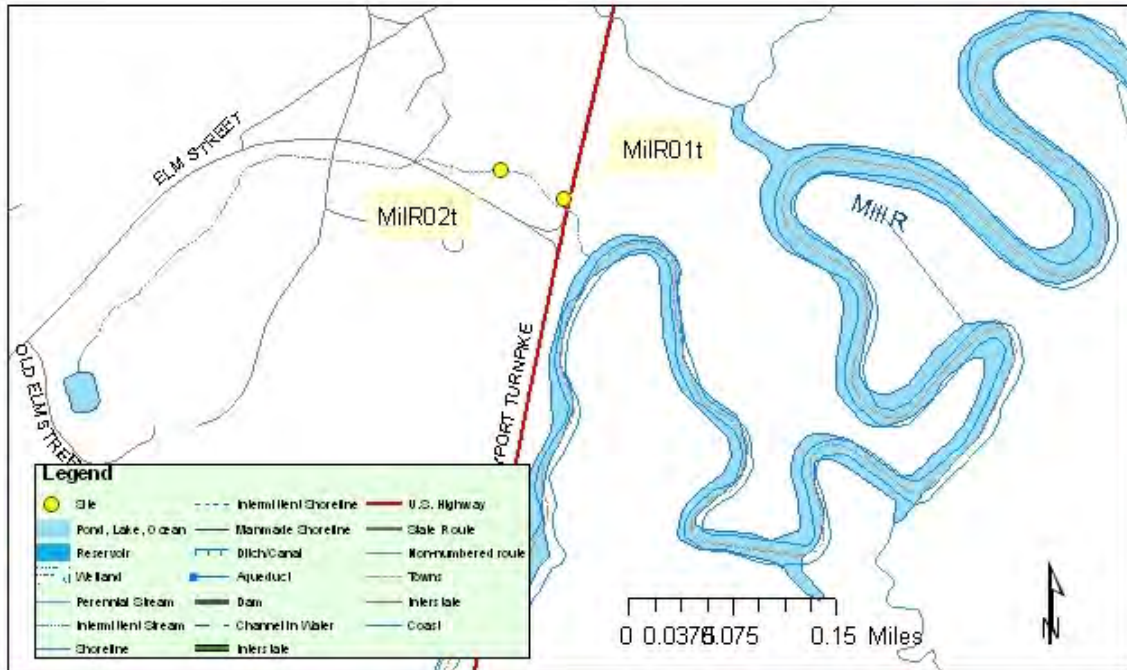
**Figure 19.** 2007 Bacteria Source Tracking Sites in a Mill River Tributary

- The sites are located on an unnamed tributary of the Mill River, near the Newbury–Rowley border.
- The contributing area of the tributary is 0.1 square miles.
- Landuse in the Mill River tributary sub-watershed is characterized as follows: Forest 47%, Residential 28%, Open Space 25%
- The sub-watershed of this tributary contains the Governor Dummer Academy campus, including a wastewater treatment plant discharge, and also a large amount of undeveloped land.
- This unnamed tributary is not listed as a segment in the 2006 Integrated List of Waters.
- The Town of Newbury is a Phase II community, with 5% sewerred and 95% on septic systems.

- Sites were chosen to bracket the Governor Dummer Academy Wastewater Treatment Plant discharge.
- On the October 18 sampling date, bubbles and a detergent odor were observed at the site downstream of the WWTP discharge. A Chemetrics MBAS detergent test kit was used to analyze duplicate samples collected at the site, and both samples yielded a detergent concentration of 0.75 ppm (or mg/L). Surfactants will be included among the monitoring requirements in the next NPDES discharge permit for this facility.
- **Actions to be taken:** 1) No actions are recommended at this time.
